METAL FATIGUE IN VESSEL STRUCTURES DUE TO DYNAMIC MOVEMENT

Abstract: Metal fatigue that occurs due to dynamic movement in a vessel. Two case studies using reliability engineering are diagnosed with modern technology, using vibration analysis and laser alignment on their propulsion systems. These types of ships have characteristics where both have different hull structure and material type; dynamic movement will occur no matter the features of the vessel. In both studies, it was found that the propulsion systems were not installed correctly and dynamic movement was detected which results in the re-occurring faults that the vessels were experiencing. The understanding of reliability engineering needs to be used when diagnosing metal fatigue.

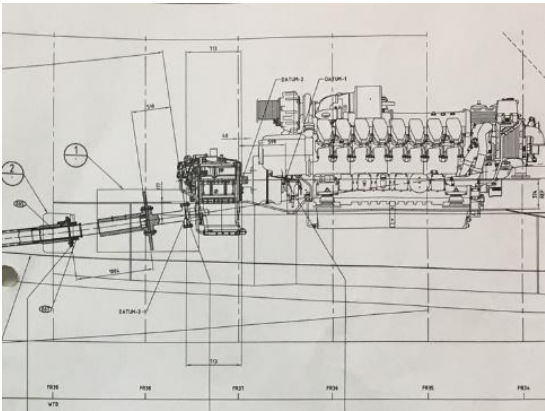
Figure 1 - Drive train configuration

Vessel x is a 55m planning monohull, that has two high revving 3500hp diesel engines with a down angle propeller shaft (see Figure 1). Vessel x had three major faults that were occurring, identified by the vessels operator:

- Bearings in the stern tube were failing which would in turn cause the shaft to bind up.
- The vessel experiences excessive vibration over 1450rpm.
- Cracking was observed occurring between the engine beds, frame 33 and at the king post.

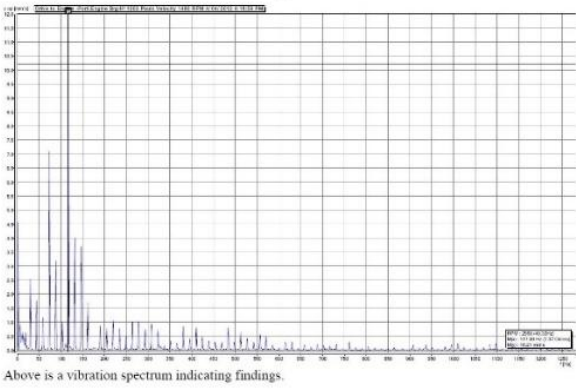
Figure 2 – VA misalignment spectrum

The three different rpm ranges tested were at idle at 1000rpm, 1450rpm and full speed at 1900rpm. The readings showed that there was an increase in misalignment, this was a good indication of dynamic movement occurring, as shown in figure 2.

The vibration readings that were recorded were over 12mm/s rms when the vessel exceeded 1450rpm. At the full speed of the vessel (1900RPM), the vibration readings were much higher, as the dynamic movement readings attempted were not achievable a shaft alignment was carried out to reduce the misalignment around 1450rpm +/- 5%. When undertaking the alignment, it must be ensured that the couplings are in tolerance and that all soft footings are removed. As the results of the sea trial following the realignment, the outcome was more than satisfied as the vessel could now achieve higher rpm range without vibrations throughout the vessel. The vessel is now achieving 1600rpm cruise speed this an acceptable change from 1300rpm. The vibration was still present from 1600-1900rpm due to the dynamic movement on the engines.

- Put in place a 3-monthly VA routine to monitor the misalignment that is occurring.
- Rewrite the alignment procedure.
- Implement dynamic movement alignment procedures.

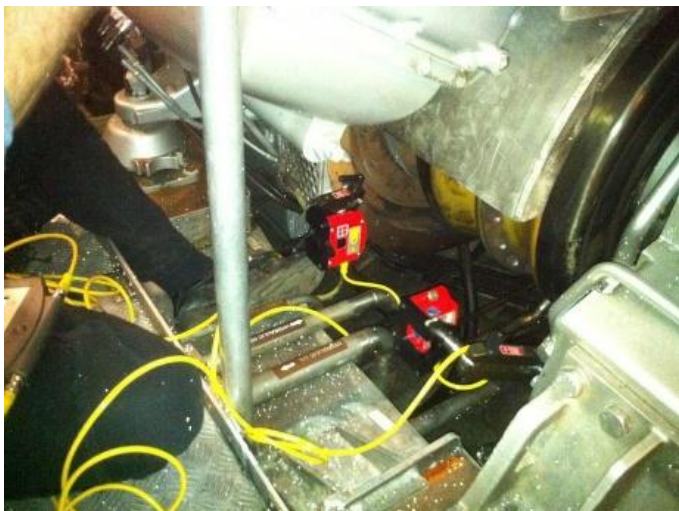
Figure 3 – Dynamic movement set up on Vessel x

Following the first test there was recorded data of progressive movement present, therefore the next step was to capture the dynamic movement. The lasers were set up between the engine and gearbox (see figure 3). A misalignment of greater than 20mm, which can be recorded by the detectors was present. Due to the excessive movement, a third test was required. The lasers were set up from the engine bell housing of the engine to the stern tube bulkhead in the engine room. At the highest rpm of the engines (1900RPM), a movement of roughly 35mm was measured as it was outside the detectors, a rule was used.

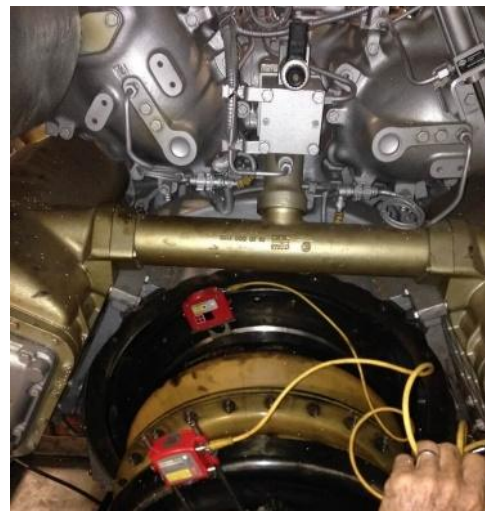
Figure 4 – Shaft alignment on Vessel x

Due to time restraints, only the starboard drive train could be tested. Adjustable rollers had to be constructed so that the centre of the stern tube bearing could be found. When the centreline of the bearing was found, the rollers were then locked off to simulate a steady bearing for the propeller shaft (Both the propeller shaft and the gearbox output shaft should rotate together for precision alignment when lasers are being used). The alignment between the shaft and gearbox were greater than the allowable tolerances. The engine to gearbox check was just within tolerance. On the inspection of the soft footings on the engine, the front left mount was loosened, a 14mm gap was present. Due to the high ductility of the vessels hull, a soft footing of this magnitude would put high stress on both the engine bed and hull of the vessel (see figure 4).

Continuous work has been done on this vessel since this job; Vessel *x* went through a remediation process. The ship was then strengthened by inserting four longitudinal beams through the engine room. Due to these four beams in place the cracks at frame 33 and the king posts have shown no signs of growing. Although forward of the vessel at frame 25 cracking has commenced. This will only keep occurring as the major fault of this ship is due to the incorrect installation and dynamic movement that is taking place in the drive train of the vessel.

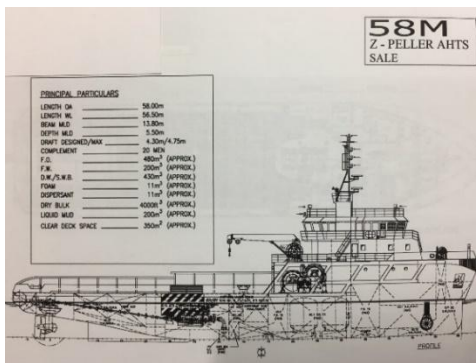
Figure 5 -Vessel y

Vessel *y* is a 58m displacement hull that has two medium revving diesel engines at 3500hp with a Z-drive thruster (see figure 5).

- High vibration that was felt throughout the ship at most rpm ranges.
- Bolts were loosening on bearing 1 on both Starboard and Port first intermediate shaft.
- Welds were cracking on the base plates of bearing housing 1 on both Starboard and Port intermediate shaft 1.
- Overheating on bearing 6 both Port and STBD intermediate shafts.

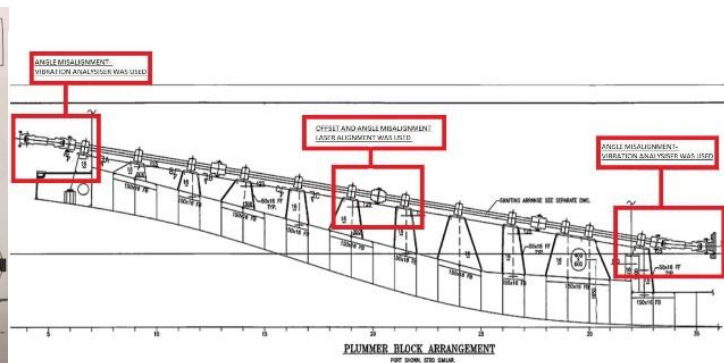
Figure 6 – VA misalignment position

The three different readings were at idle 450rpm, 600rpm and full speed of 750rpm. Readings showed that there was an increase in misalignment, this was a good indication of dynamic movement occurring. Offset and angular misalignment was observed at each coupling and Cardan shafts (see figure 6, highlighted in red).

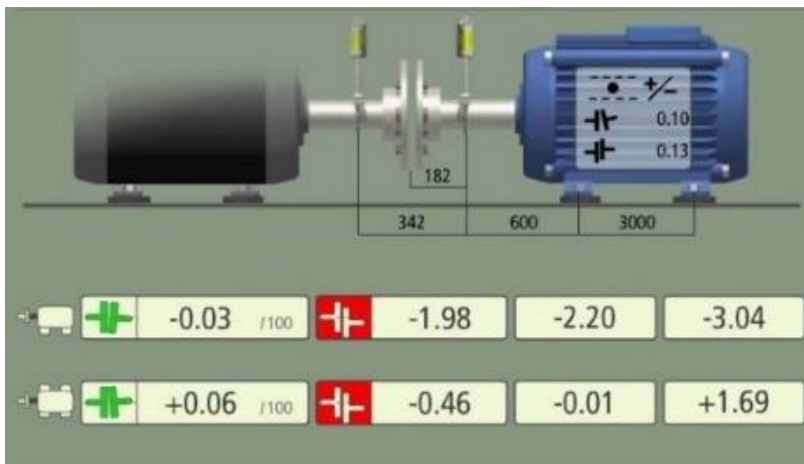
Figure 7 – Shaft alignment result

Executed alignment measurements throughout the drive train both Port and Starboard. Figure 7 is the reading from the coupling between the two intermediate shafts. This was the indication that bearing six would be over heating due to the misalignment. It was revealed that bearing 6 was a thrust bearing which was not designed to hold an 8m shaft on a 7 degree down angle. Offset brackets are used for aligning Cardan shafts, although this couldn't be done due to the intermediate shafts being at an angle of 7 degrees, therefore a third test was required.

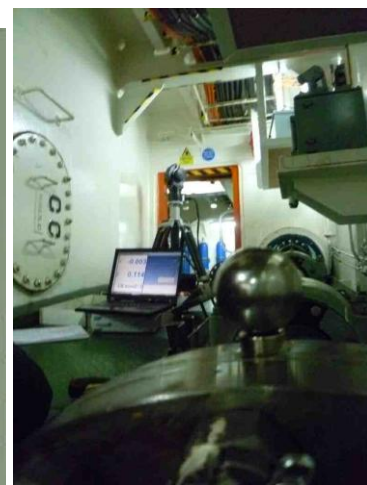
Figure 8 – 3D laser

A 3D laser Tracker was used to undertake this test due to complexities of the drive train system. To begin the alignment the engine block was used as the reference, then the tracker zeroed in the coupling on the clutch box, both intermediate shafts and Z-drive thruster. The distance between the clutch box and Z-drive thruster was 16m apart. The offset misalignment was 13.7mm and the angle angular misalignment was 6.5mm. The two intermediate shafts had high stress applying to the bearing housing as these shafts carried the misalignment (see figure 8 and 9).

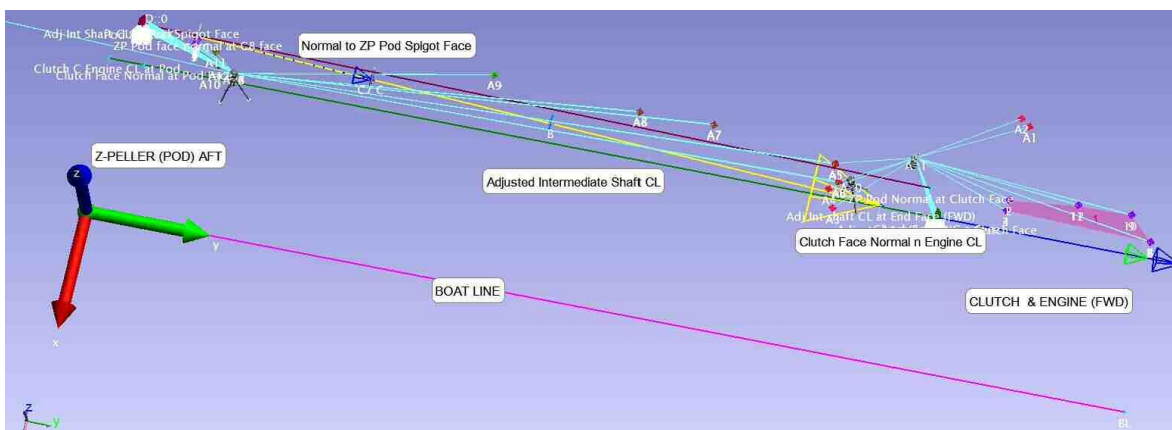
Figure 9 – 3D laser measurement results

The vibration readings were over 12mm/s rms through the drive shaft. The starboard bearing 1 on the intermediate shaft was 23mm/s rms due to one loose bolt and cracked welds in the base plate. The intermediate shafts needed to be redesigned between the clutch box and the Z-

drive thruster. The Z-drive also required repositioning to be parallel to the clutch box. Neither of these modifications were an option at the time. With the 3D tracker, an accurate calculation could be made on the Cardan shafts. After looking at the specification of the Cardan shaft, the shaft works highly within the spline tolerance between the two universal joints. This spline allows for the absorption of axial loads when the couplings are not parallel with each other. The Cardan shaft was on the limit of its design for axial movement. Due to the maximum limit on the Cardan shafts when the dynamic movement occurs, the Cardan shaft then became overloaded. Causing the faults in bearing 1 such as the bolts coming loose and cracking welds in the base plate. This explains the high vibration throughout the whole vessel.

- Redesign the drive train between the clutch box and z-drive thruster as this will fix bearing faults, specially bearing 1 and 6.
- Introduce new alignment procedure with new drive train to allow for dynamic movement. The failure of the high vibration throughout the vessel will be minimised
