CONSIDERATION ON LIMITING THE ELEMENTS OF HUMAN FACTOR INFLUENCE ON BREAKDOWNS OF SHIP'S MACHINERY ILLUSTRATED BY SOME CASE STUDIES

Jerzy Listewnik¹, Antoni Wiewióra²

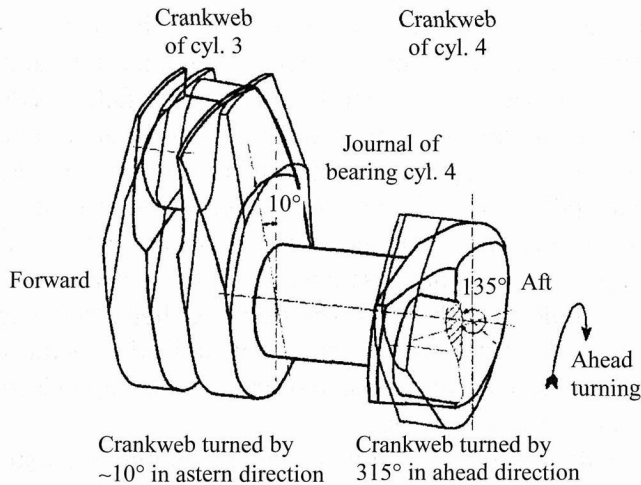
A container ship built in 1995 of 2480 TEU capacity and a MAN-B&W 6S70MC main engine of 16860 kW, 91 rpm suffered a very serious main engine crankshaft breakdown two crank webs on cylinders No. 3 & 4 have slipped. Crank web on cylinder No. 3 has been turned by 10° in astern direction and cylinder No. 4 crank web was shifted by 315° in the ahead direction (see Fig. 3). Following sequence of events took place: Automatic ME safety system triggered an engine slow down due to "Piston Cooling Flow on cylinder No.

Fig. 3. Detailed picture of damage to crank webs cylinders No. 3 and No. 4

3" announcement. The engine was stopped manually by the engineer on watch. The ship was in ballast condition, stormy weather caused the ship to roll up to 45° both sides.

The engineers checked the piston cooling oil flow-found o.k. Drain pipe from under piston space of cylinder No. 3 was checked and no flow present – o.k. (but later it was stated that the drain pipe was clogged). After 5 min. M.E. stoppage, the engine was started again in ahead rotation. Immediately after that an enormous thump was heard (like an internal explosion), and the engine brought to a stop. Cause stated: hydraulic impact in combustion chamber of cylinder No. 3 what has caused the slippage of crank webs cylinder No. 3 and cylinder No. 4. During later inspection it was discovered that the piston crown of cylinder No. 3 had two cracks (an inner crack and an outer) during

The question arises if this damage could be avoided. The straightforward answer is yes. It could be avoided if routine procedures were observed. It means that the turning gear was clutched in and the engine rotated with open indicator cocks to observe eventual emission from the indicator cocks. If this procedure would be carried out the engineers could notice the oil being ejected from cylinder No. 3 but this was not done, the normal procedure has been violated with fatal results. The only excuse concerning the engineers action can be the state in which the ship was sailing (heavy rolling) and the clogged drain pipe from the under piston space of cylinder No. 3, but if this drain valve has been regularly opened it would not be choked so again some negligence on the engine crew side.

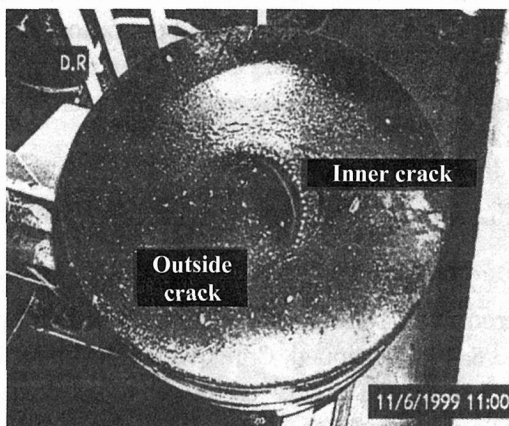
- Damage
Cracks in piston crown
Cause:
- Hydraulic thump in combustion chamber of cyl. No. 3
 - Slippage of crankwebs on cyl. 3 & 4

Fig. 4. Damage details on piston crown of cylinder No. 3

the 5 min engine stoppage the cooling oil seeped through into the combustion chamber of cylinder No. 3 (see Fig. 4).

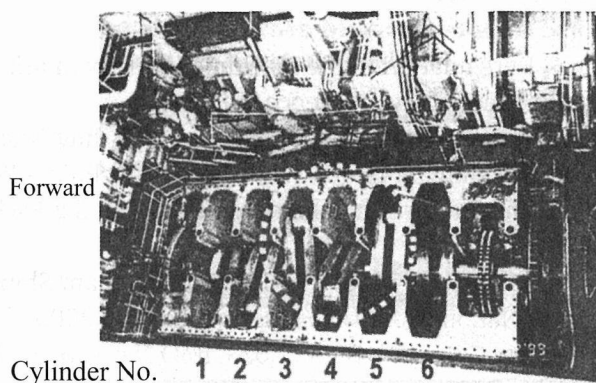
The final picture of the damage (see Fig. 5), crank webs of cylinders No. 1, 2, 3 turned by about 35° in relation to crank webs of cylinders No. 4, 5, 6. The aft crank web of cylinder No. 3 and forward crank web of cylinder No. 4 have shifted outwards by about 2 mm. Undertaken temporary repair to bring the ship from Azores area to Hamburg; piston of cylinder No. 3 pulled out. Cylinder No. 1 and No. 2 cut off. Permanent repair – first it was intended to bring back the slipped crank webs into original position but was given up due to the excessive turning of the crank webs, second proposal was to build in new crank webs but this turned out to be too expensive compared with fitting a new crankshaft.

Damage Picture

- Crankwebs of cyl. 1, 2, 3 turned by about 35° relative to crankwebs 4, 5, 6

- Aft crankweb of cyl. 3 and forward crankweb of cyl. 4 projecting about 2 mm outwards

Fig. 5. Picture of turned crank webs seen from top of the engine bedplate
