IAMU 2017 Research Project
(No. 20170401)

Marine Structural Failures Database
(MarStruFail)

University of Rijeka, Faculty of Maritime Studies (UR-FMS)

August 2018

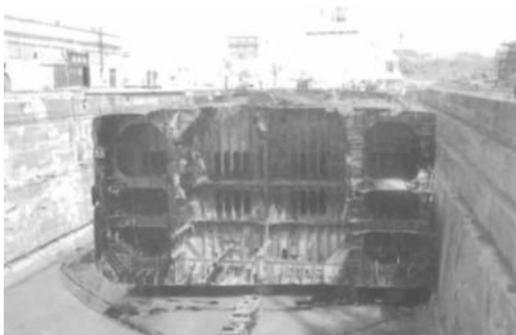
Fig.3 Extent of damage [2.1]

The fracture occurred forward of the wash bulkheads in No. 3 tank. The failure of the bottom shell plate occurred as a clean break with little or no deformation. Significant deformation was present on the ship's plate on both sides in the region 20-30 ft (6-9 m) below the deck plate. The failure appeared to be macroscopically brittle, showing signs of little or no ductility.

The site with the most significant damage was the port bilge keel. There was no evidence of the crack having arrested at any point along the bottom shell. Visual inspection had shown that the crack initiation occurred from the fatigue-cracked areas situated in the ground bar weld metal, eventually progressing into the bulb and the shell due to inadequate dynamic toughness of the fillet welds, due to the low sea water temperature (-1°C), connecting the mentioned sections of the ship.

The initiation of the fracture was due to the classic combination of poor weld metal toughness and high stresses in the presence of a defect.

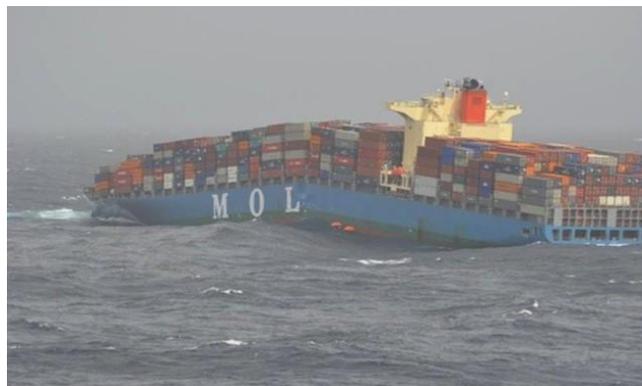
Fig. 2. Damage extent

Results of the investigation had shown that the hull fracture originated from the bottom butt joint in the mid-ship part. A possibility that the load's upper limit exceeded strength's lower limit was also estimated using probabilistic approach. Furthermore, safety inspections of the MOL Comfort sister ships have shown buckling deformations (concave and convex) of the bottom shell plating of up to 20 mm (4 mm allowable) in height observed near the centre line.

Finally, a numerical analysis of the ship hull considering the load history was done. The investigation concluded that the load of the vertical bending moment probably exceeded the hull girder ultimate strength when the deviations of the uncertainty factors are taken into account, which caused the bottom shell plates to buckle due to excessive load. The reduction of breadth of bottom shell plate between girders increased the stress in the girder which yielded in the lower

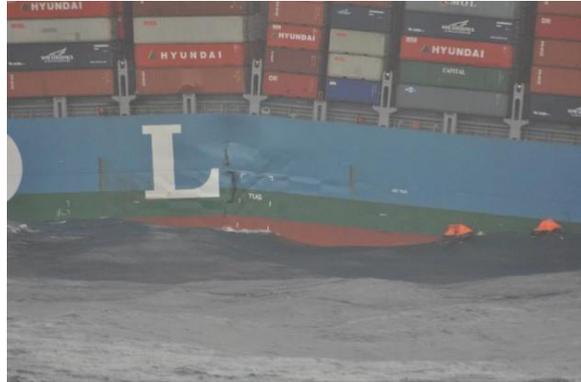
Fig.3 Damage extent (detail)

The above-mentioned stresses superimpose one to the other resulting in an always-compressive condition both in the longitudinal and transverse directions in the middle part of the double bottom structure. In other words, the stiffened bottom panels are subjected to a multiaxial compressive stress composed of compressive stress in the longitudinal direction due to vertical bending moment, compressive stress in the transverse direction due to side sea pressure and double bottom local stresses due to the lateral loads both in the longitudinal and transverse directions.

In conclusion, the mechanism of the buckling collapse of the bottom shell plates to the hull girder fracture can be described as follows: “the upward loads of bottom sea pressure are dominant among the lateral loads acting on the double bottom structure of container ships. The lateral loads are mainly supported by I beams with flanges of bottom shell plates and inner bottom plates and with webs of girders and floors. Once bottom shell plates are locally buckled and collapsed with plastic deformations, the effective breadth of the flange of bottom shell plates attached to the girder is reduced. The reduction of the effective breadth of bottom shell plate flange increases the compressive bending stress of the girder caused by the lateral loads. As the result of the superimposing with vertical bending stress of compression, the lower half of the girder partly yields.

Bending strength of double bottom structure against the lateral loads is reduced due to the local buckling collapse of bottom shell plates and due to the partial yielding of adjacent girders, which causes the subsequent propagation of the buckling collapse of bottom shell plates and the yielding of the girders leading to the hull girder fracture finally.

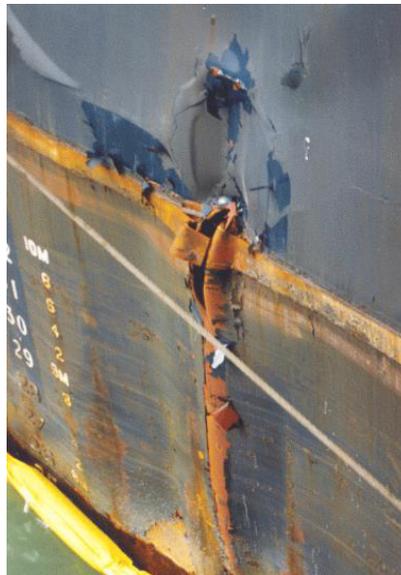
Fig. 2. Damage detail

Crack initiation:
Hogging/bending moment about 2.3 times the maximum permissible (sea going)
Crack propagation:
Loss of structural strength
Analysis results and conclusions
<p>The Algowood experienced a sudden, major structural hull failure, in the form of extensive structural buckling and distortion on the deck above the water line in the cargo holds 3 and 4 part of the ship. The inspection in dry dock revealed deformations, distortions, and localised fractures in the forward and after sections of the bottom shell plating. These were caused by the vessel contacting and settling on the bottom during the event.</p> <p>The ultrasonic material thickness measurements, conducted in dry dock, showed wastage of 1 to 7% in the shell, bilge, keel, and bottom structural members, none of which exceeded accepted limits at which replacement of the material would be required.</p> <p>Furthermore, chemical and mechanical characteristics examination of the material showed no abnormalities that would negatively affect weldability. The material conformed to Lloyds Grade A steel.</p> <p>Still water bending moment calculations have been performed after the accident, showing that, immediately before hull failure, the vessel was subjected to a hogging/bending moment about 2.3 times the maximum permissible (sea going) moment. This kind of bending moment puts the main deck plating in tension and the bottom structure in compression. The hogging condition was due to the excess of weight over buoyant support at the ends of the vessel.</p> <p>The investigation had concluded that:</p> <ul style="list-style-type: none"> • The intended loading and de-ballasting sequence was violated and the vessel was subjected to excessive bending stress, which resulted in structural failure of the hull. The disposition of the cargo and ballast at the time of the failure caused a still water bending moment about 2.3 times the maximum permissible. • A lack of feedback communication between the port personnel as well as the inadequate frequency of draught marks reading during loading were noticed <p>The magnitude of stresses that occurred due to inadequate loading sequence remained unnoticed and unappreciated by shipboard personnel, as the ship's approved loading manual on board the vessel contained representative loading conditions but does not outline loading and de-ballasting sequences.</p>

- Cargo handling policy modified in order to include procedures that require all split loading and unloading revision by the company to determine if the proposed load/unload falls within the allowable limits set for various vessels with respect to stress and shear forces.
- Personnel additional education regarding stresses and strain during cargo handling operations
- Stricter control of loading procedures needed
- The importance of loading distribution on local high stress occurrence
- The importance of adherence to loading manuals and loading plans

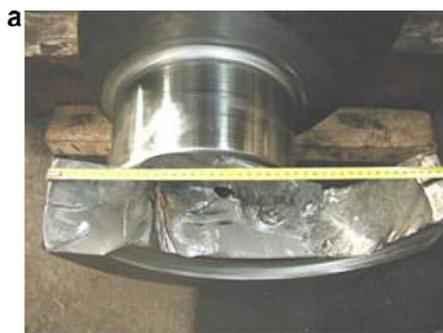
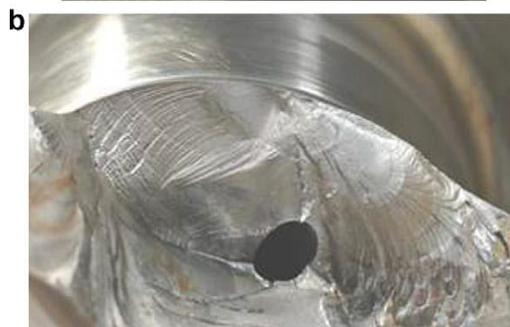
Fig. 2. Fracture details

During the investigation of a crankshaft failure, a microscopy (eye seen) observation has been carried out showing that the crack initiated on the fillet of the crankpin by rotary bending and the propagation was a combination of cyclic bending and steady torsion.

The fatigue fracture appears in two distinct surfaces: a smooth almost to perpendicular to the crankshaft and a second one in a horizontal plane with the crankshaft, with transition zones between two surfaces. Further analysis has excluded any material defect as possible causes of the failure, so the catastrophic fracture of this marine crankshaft was by fatigue, as a combination of rotating bending with steady torsion

- Fast crack propagation indicates relatively high bending stress levels
- After the crack initiation by rotating bending, the effect of steady torsion becomes significant

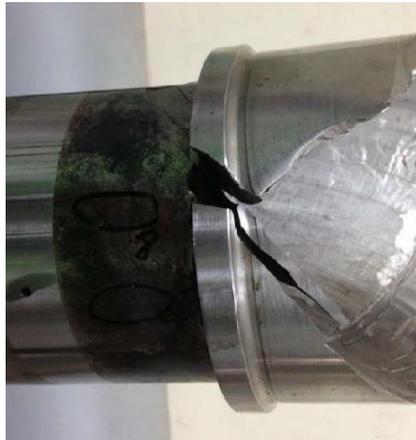
Fig. 2. Shaft crack detail

Crack propagation:	
45° rotational direction in a helical shape	
Analysis results and conclusions	
The design procedure and calculation must be compliant to classification society's rules. The main idea is to make a real marine propulsion system that can enable an efficient, reliable, safe,

- The importance of geometry details in the design phase

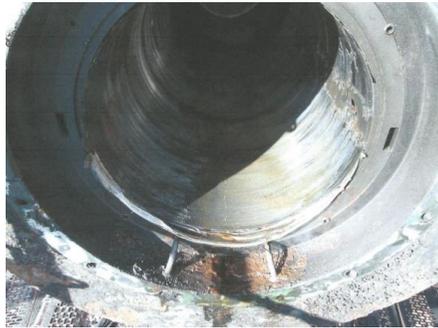
Fig. 1. Condition of aft and fore of stern tube bearing

- Shaft line alignment and crankshaft springing should be checked periodically or the structural health monitoring system should be installed.

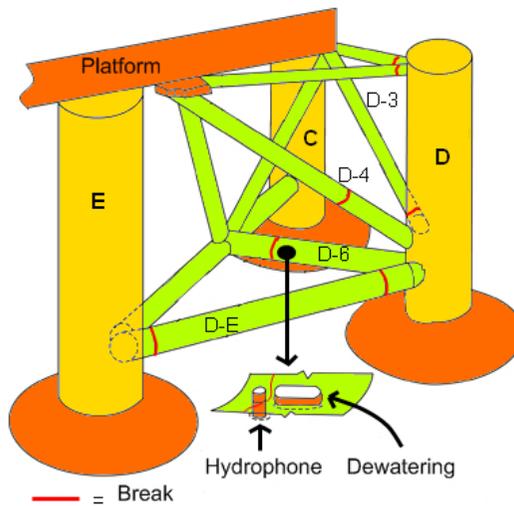
Fig. 2. Fractures on the rig

The investigation has shown that material properties, welding quality as well as the design process played a significant part in the failure of the structure. Stability and buoyancy aspects of the structures were inadequate; the design did not include additional strengthening of highly stressed braced (D6) as important. The influence of the hydrophone attachment on the fatigue life of the structure was overlooked, all of which led to a fatal accident with 123 lives lost.

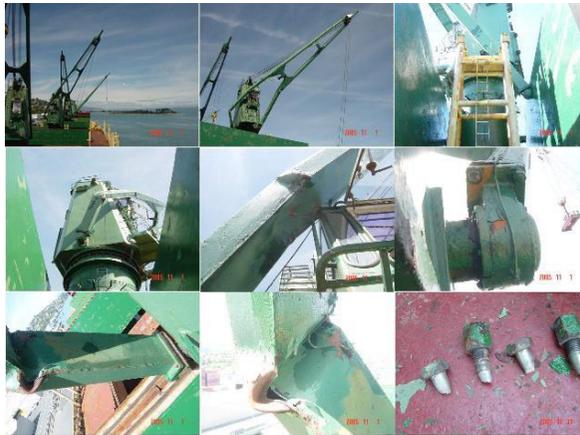
Fig. 2. Failure details

References
1. Maritime New Zealand, Accident Report No. 05 3888 – Crane Failure Sea Angel
Summary
<p>On October 31st 2005 whilst Sea Angel was loading logs at the port jib arm of a hydraulic crane detached from the crane’s heel pin, causing serious damage to the jib of the crane. There were no injuries. The subsequent investigation has found severe negligence during inspection and maintenance activities, as well as non-adequately dimensioned heel bolts that proven critical for certain crane operations. Possible pre-existing cracks were found on the bolts indicating that this particular accident has been caused by a combination of poor maintenance and fatigue.</p>
Legacy/Lessons learned
<ul style="list-style-type: none"> • The importance of inspection & maintenance requirements/recommendations • The importance of adequate information circulation and feedback information in and from exploitation • The importance of crew education in recognizing and assessing equipment condition and behaviour during exploitation
