IAMU 2017 Research Project
(No. 20170401)

Marine Structural Failures Database
(MarStruFail)

University of Rijeka, Faculty of Maritime Studies (UR-FMS)

August 2018

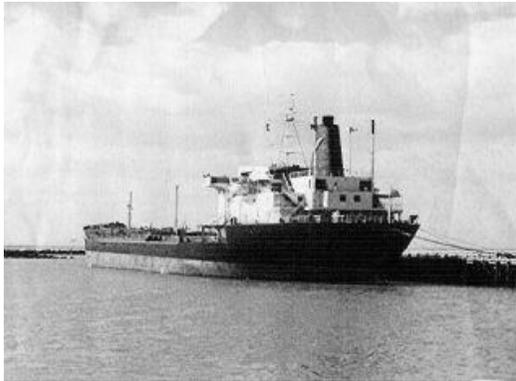
The fracture occurred forward of the wash bulkheads in No. 3 tank. The failure of the bottom shell plate occurred as a clean break with little or no deformation. Significant deformation was present on the ship's plate on both sides in the region 20-30 ft (6-9 m) below the deck plate. The failure appeared to be macroscopically brittle, showing signs of little or no ductility.

The site with the most significant damage was the port bilge keel. There was no evidence of the crack having arrested at any point along the bottom shell. Visual inspection had shown that the crack initiation occurred from the fatigue-cracked areas situated in the ground bar weld metal, eventually progressing into the bulb and the shell due to inadequate dynamic toughness of the fillet welds, due to the low sea water temperature (-1°C), connecting the mentioned sections of the ship.

The initiation of the fracture was due to the classic combination of poor weld metal toughness and high stresses in the presence of a defect.

Fig. 1. MV Kurdistan [2.1]

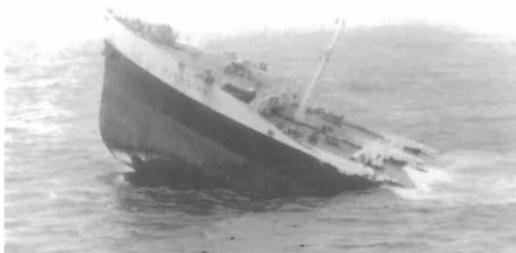
The subsequent breaking of the ship in two was inevitable due to the extensive structural damage caused by the fatigue crack propagation.

Fig. 2. Sinking of MV Kurdistan [2.1]

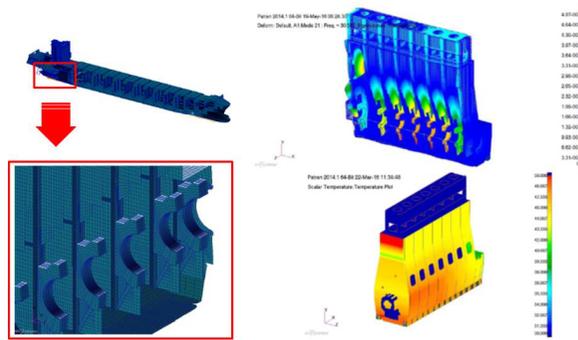
Fig. 3.1. Numerical model of the engine body-ship hull interaction and thermal loads presenting a threat to structural integrity [7]

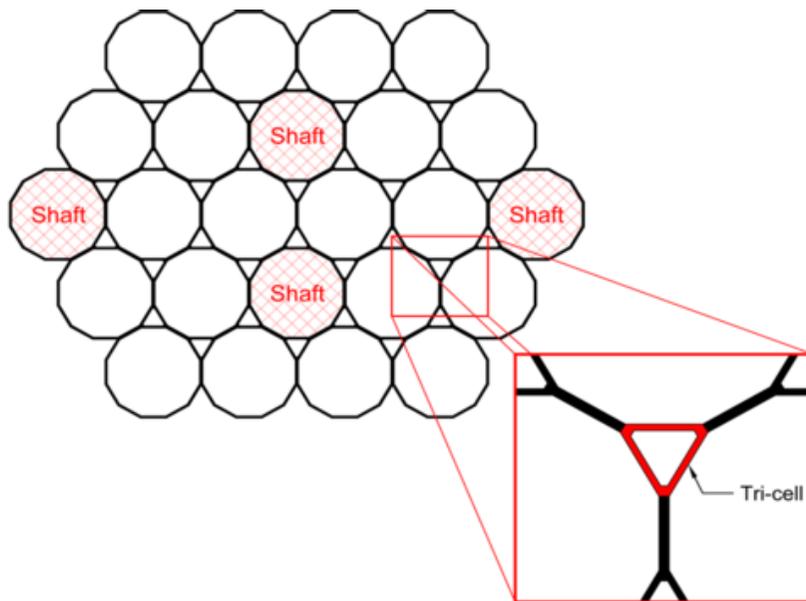
Fig. 2. Plan view of SLA-1 buoyancy cells

- The need for extreme care and detail in design
- Importance of having experienced engineers verify computer-generated design work to ensure the proper use of analysis and design techniques
- Revised design philosophy with greater attention to construction details and numerical analysis results control

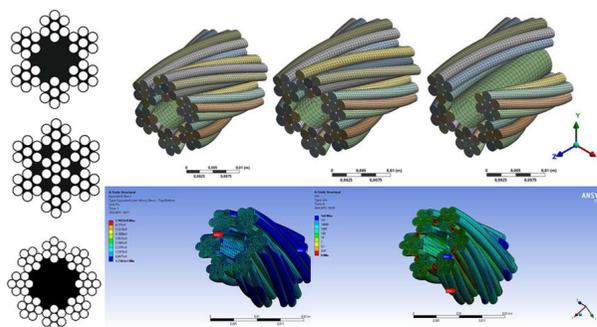
Fig. 5.1 Numerical analysis of remaining fatigue life of a wire rope

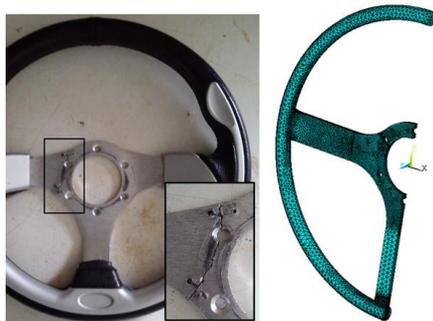
Fig. 7.3.1. Numerical model of fractured speed boat steering wheel.
